# Local and Regional Tectonic Influence of Territory on Geohazard of Dam of Radioactive Waste Tailings (Ukraine)

Uranium production tailing ponds in Kamyanske (Ukraine) are objects of increased radioecological danger. Violation of the stability and integrity of containment dams threatens the uncontrolled spread of radionuclides. The purpose of this study is to comprehensively assess the factors affecting the technical condition and environmental safety of the Sukhachivske tailing dam. The study included a visual inspection and detailed geophysical work using the natural pulse electromagnetic field of the Earth (NPEMFE) method. This method was chosen to identify hidden filtration paths and stress zones in the body of the earth dam. An analysis of the spatial distribution of waterlogging, filtration, and fissuring in the hydraulic structure was performed. Based on the results of the NPEMFE survey, six zones with varying degrees of waterlogging and stress-strain states of the structure were identified. The presence of externally unmanifested filtration paths and suffusion areas was established, and a tectonic scheme of fracture development in the dam body was compiled. A correlation

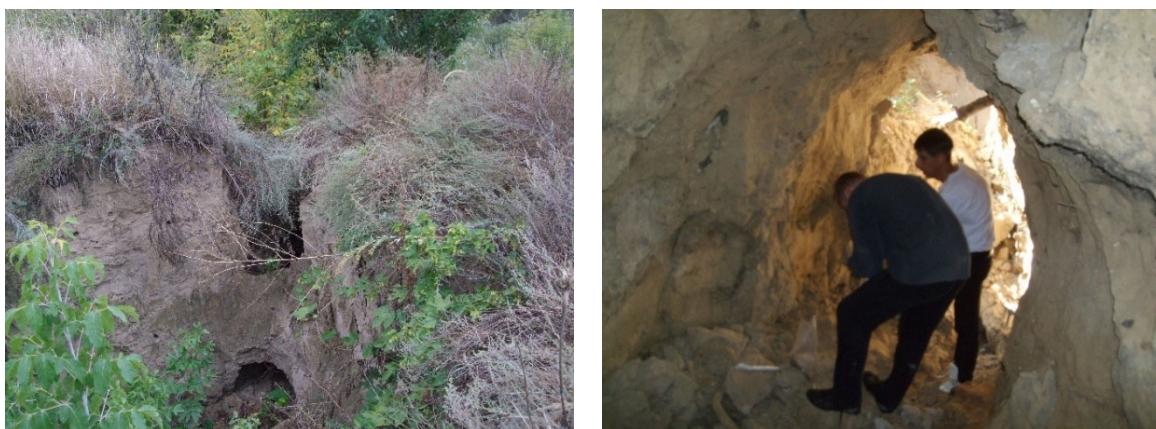
The research was conducted in two stages: visual inspection and geophysical surveying. Visual inspection: In the first stage, a detailed visual inspection of the dam was carried out [17]. This allowed us to record numerous external signs of degradation, such as suffusion funnels, surface collapses, and underground suffusion channels up to 7 m long and 2–2.5 m in diameter (Figure 3). It was noted that despite the absence of traces of active surface erosion, the presence of large suffusion forms indicates a constant inflow of water through hidden filtration zones.

**Figure 3.** Manifestation of suffusion processes in the dam of the Sukhachivske tailing pond. Own photos.

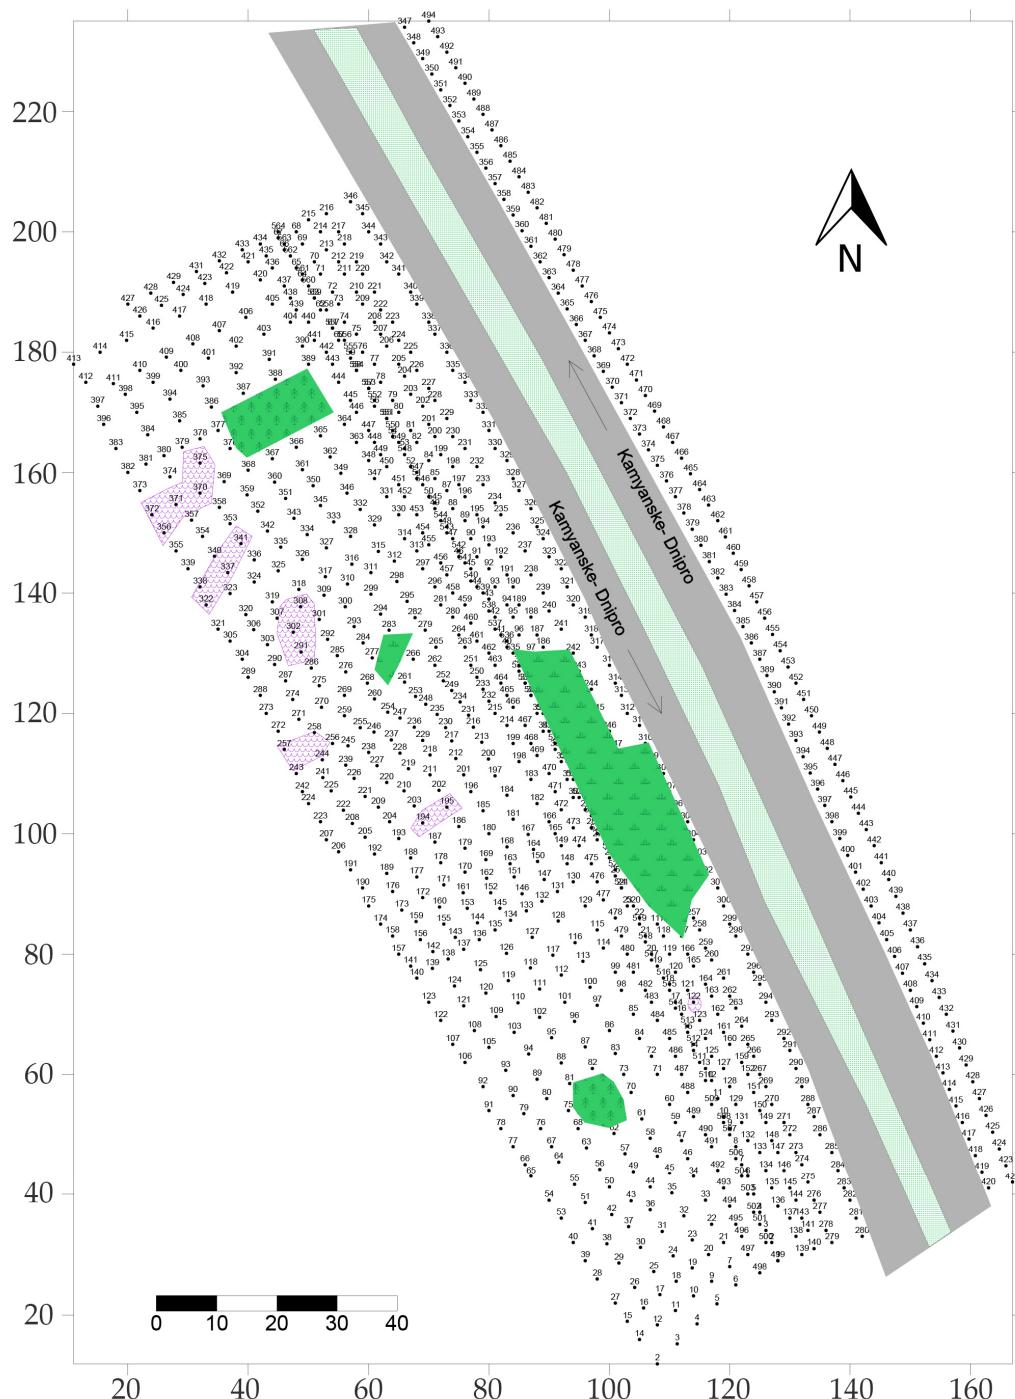
**Figure 5.** Map of actual NPEMFE survey data for the upper dam of the Sukhachivske tailing pond. Green color—areas of tree and shrub vegetation; purple color—areas of surface suffusion; numbers indicate NPEMFE survey points.

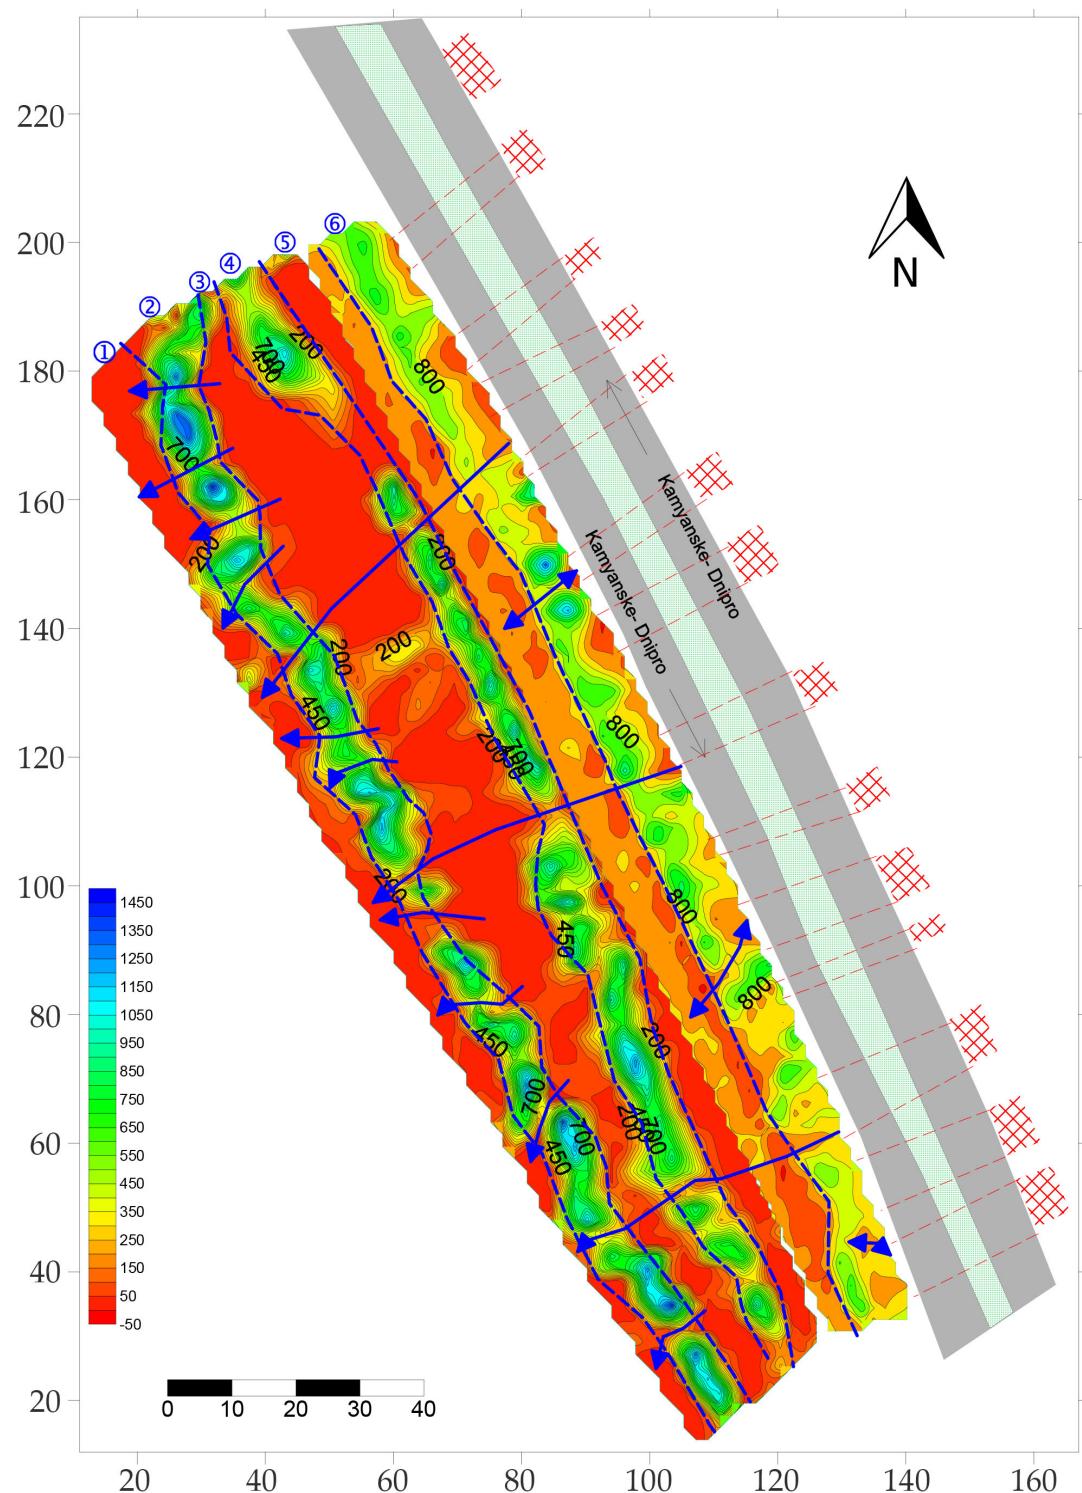
Based on the results of the geophysical surveying, maps of NPEMFE pulse density were created (Figure 6). A joint analysis of the maps and diagrams allowed us to identify six zones that differ in their geophysical characteristics and degree of waterlogging (Figure 7):

- *Zone 1.* It is characterized by low NPEMFE values, indicating already formed, stable filtration areas. Externally, this manifests itself in the form of suffusion craters and depressions.

- *Zone 2.* It has elevated NPEMFE values. This may indicate either an area with low water saturation (after repair) or, more likely, the development of landslide processes, where the massif is in a stressed-deformed state.

- *Zone 3.* It has the lowest NPEMFE values. This indicates strong waterlogging, which is also confirmed by the significant amount of vegetation and reed thickets.

- *Zone 4.* An area with elevated values, which has weak waterlogging along the ground road. This is probably due to its constant compaction as a result of the passage of motor vehicles used by the tailing pond security service.

- *Zone 5.* It is probably related to defects in the waterproofing of the concrete channel that drains water from the road, causing the rocks to become saturated.

- *Zone 6.* It is located between the channel and the motorway, characterized by waterlogging (reed beds). Areas of reduced NPEMFE values adjacent to the road indicate possible filtration and suffusion directly under the motorway.

**Figure 6.** Interpretation scheme for NPEMFE surveys. Blue dotted lines and numbers in circles indicate zone boundaries and numbers (explanation in the text). Blue arrows indicate the directions of water filtration through the dam body. The red dotted line indicates the predicted areas of waterlogging.

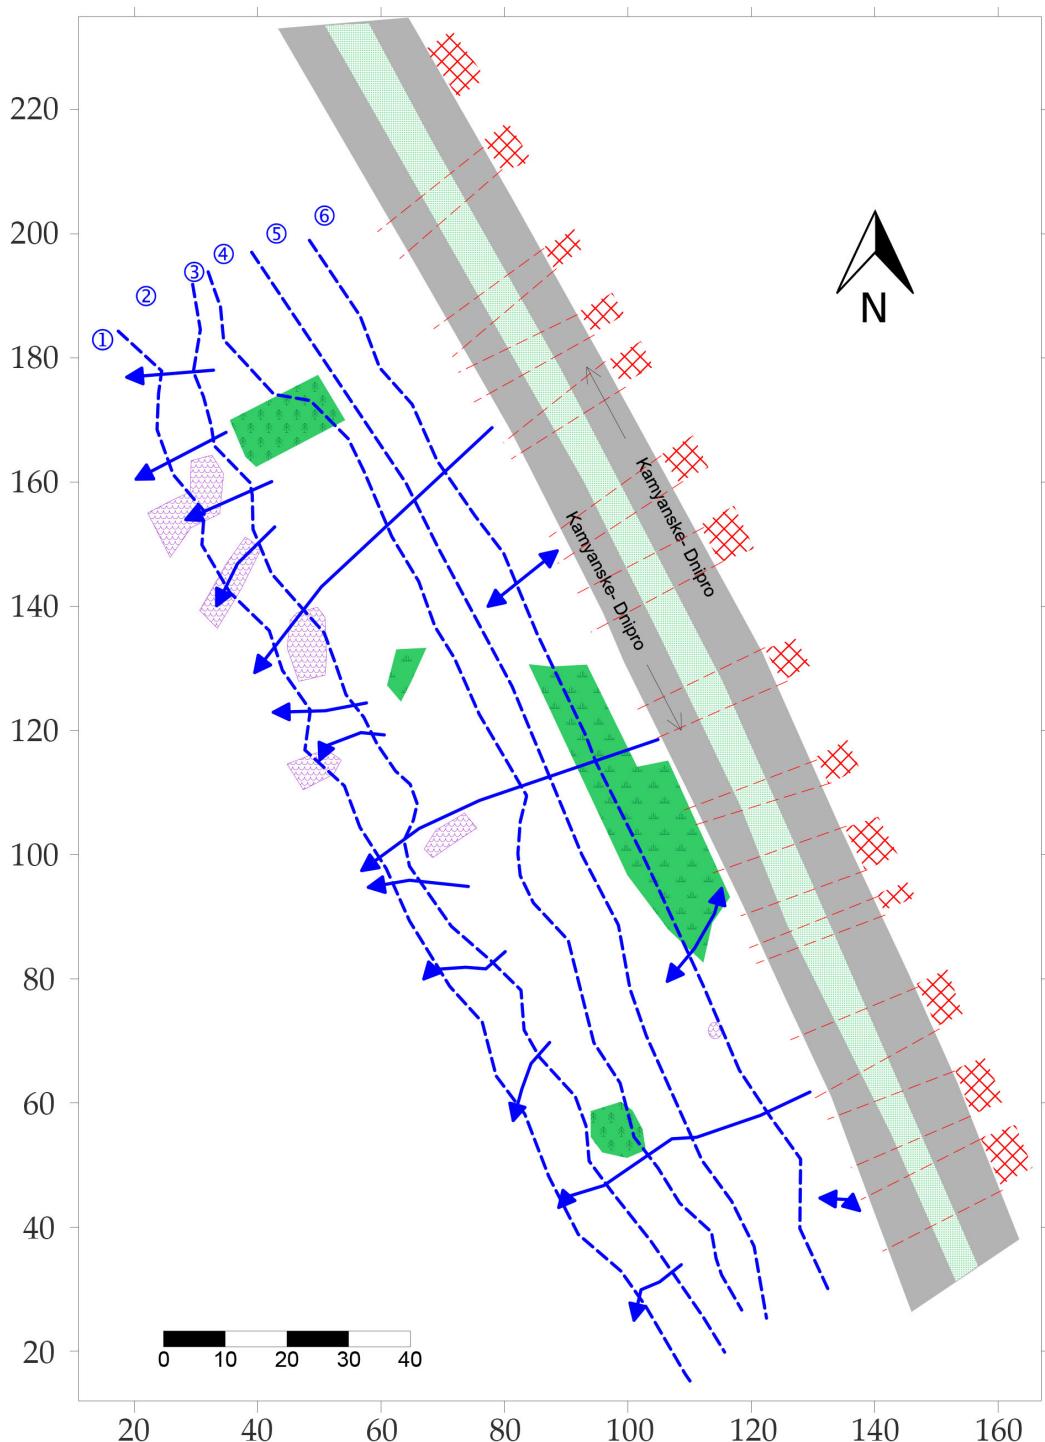
**Figure 7.** Generalized interpretation scheme for NPEMFE images. Green indicates areas of vegetation growth, purple indicates areas of surface suffusion. Blue dotted lines and numbers in circles—boundaries and numbers of zones (explanation in the text). Blue arrows—directions of water filtration through the dam body. Red dotted line—predicted waterlogging zones.

These fracture zones are the main pathways for water movement, which was confirmed by comparison with the directions of solution movement from the storage pond (shown in Figures 6 and 7).

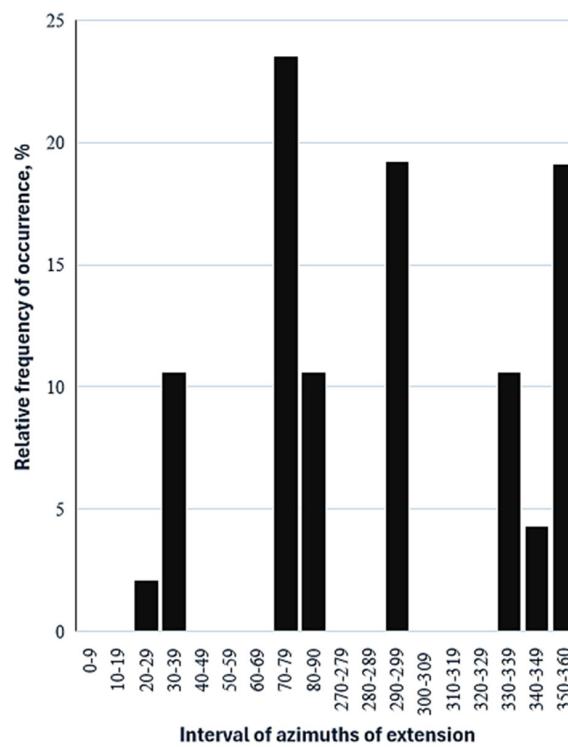
systems is shown in a bar chart (Figure 8). It can be seen that the following azimuths of extension are dominant:

- diagonal cracks:  $70\text{--}79^\circ$  ( $\pm 5^\circ$ );
- meridional:  $350\text{--}359^\circ$  ( $\pm 5^\circ$ );
- sublatitudinal:  $290\text{--}299^\circ$  ( $\pm 5^\circ$ ).

**Figure 8.** Diagram of the fracturing of the Sukhachivske tailings.

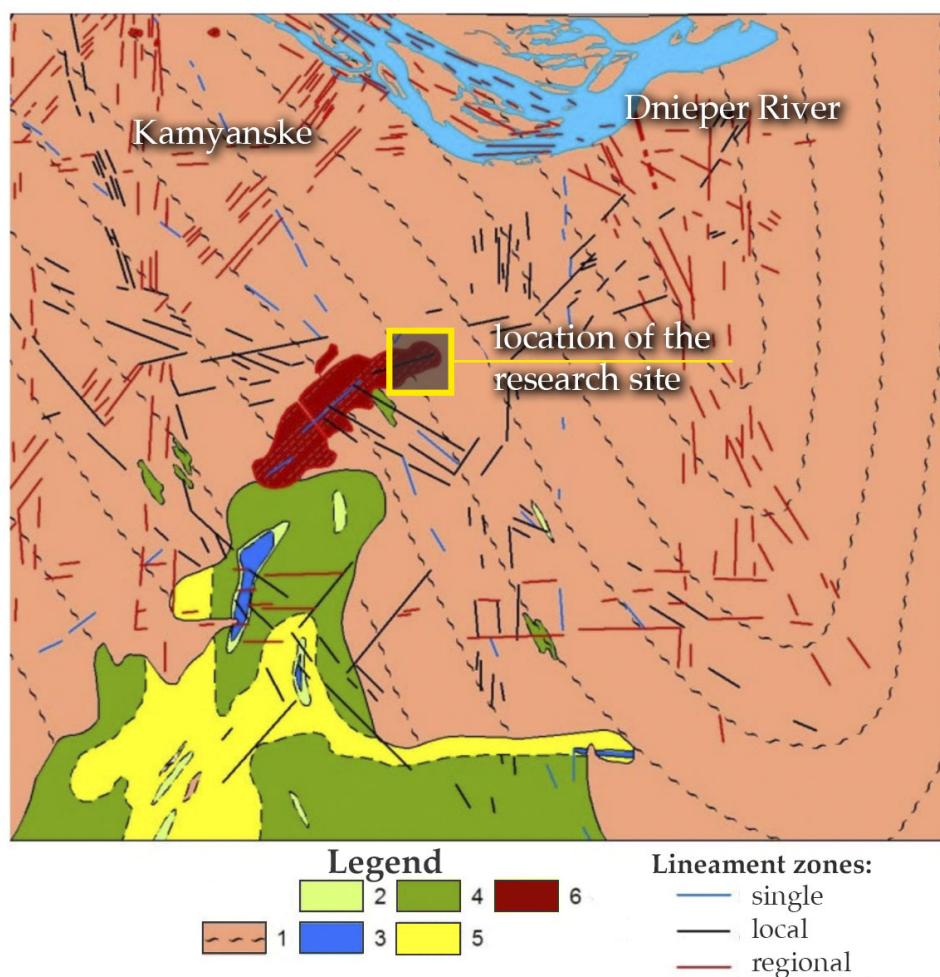
**Figure 9.** Geological and petrographic map of the Sukhachivske tailing pond area of Precambrian crystalline rocks and its comparison with linear structures identified as active at the latest stage of development [27,29]. Legend: 1—plagiogranites and migmatites; 2—talc–actimite–chlorite schists; 3—serpentinites; 4—epidiabas, amphibolites, and amphibolite-derived schists; 5—quartz–chlorite and sericite–chlorite schists; and 6—radioactive waste Sukhachivske tailings.

Our data show that the dam, located at the intersection of three LZs, is affected by modern tectonic movements (+4 mm/year [29]), which form inherited zones of increased permeability in its body. This may indicate that the development of waterlogging and

filtration zones is associated with the formation of cracks spatially confined to lineament zones. It is these fracture zones that serve as primary conduits for water and “channels” for further filtration, suffusion, which is radically different from previous ideas about degradation solely under the influence of surface waters.
