# Local and Regional Tectonic Influence of Territory on Geohazard of Dam of Radioactive Waste Tailings (Ukraine)

Uranium production tailing ponds in Kamyanske (Ukraine) are objects of increased radioecological danger. Violation of the stability and integrity of containment dams threatens the uncontrolled spread of radionuclides. The purpose of this study is to comprehensively assess the factors affecting the technical condition and environmental safety of the Sukhachivske tailing dam. The study included a visual inspection and detailed geophysical work using the natural pulse electromagnetic field of the Earth (NPEMFE) method. This method was chosen to identify hidden filtration paths and stress zones in the body of the earth dam. An analysis of the spatial distribution of waterlogging, filtration, and fissuring in the hydraulic structure was performed. Based on the results of the NPEMFE survey, six zones with varying degrees of waterlogging and stress-strain states of the structure were identified. The presence of externally unmanifested filtration paths and suffusion areas was established, and a tectonic scheme of fracture development in the dam body was compiled. A correlation

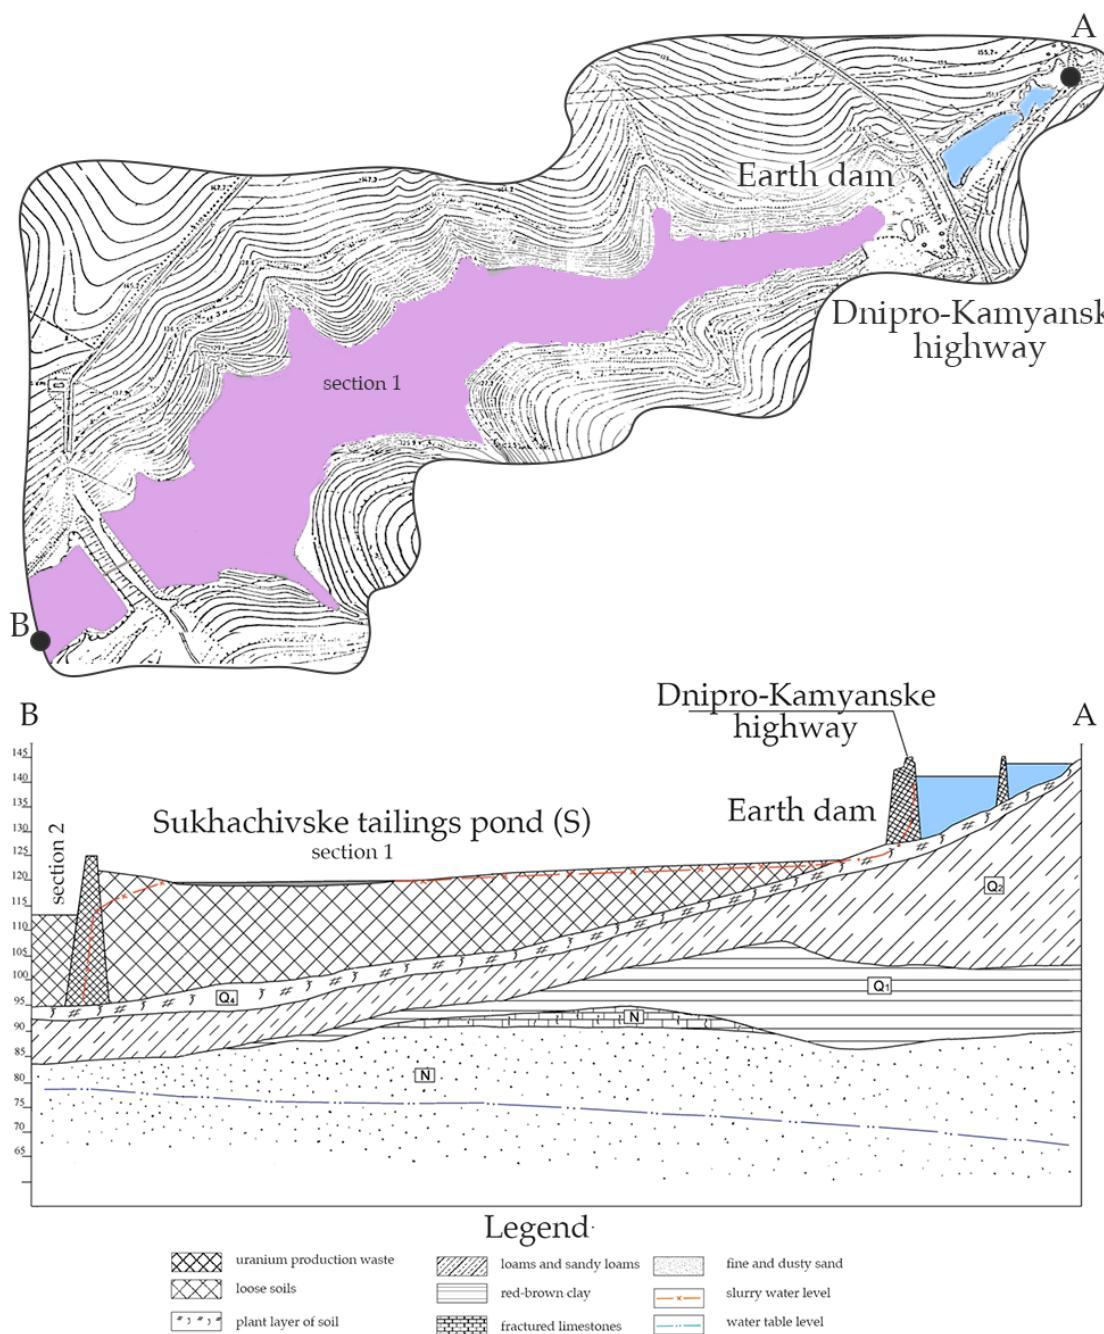
**Figure 2.** Terrain relief and geological profile along the axis of the first section of the “Sukhachivske” tailings pond (compiled by the authors based on data [16]).

The obtained results indicate the danger of dam failure and the release of water masses that could form a mudflow. This flow is capable of destroying the protective layer covering the waste (see Figure 2), which will lead to its exposure, spillage across the area of the first section, and release into the atmosphere. We do not consider the risk of destruction of the lower retaining dam, since the capacity of the first section is capable of completely
